# KPB SOLDOTNA ELEMENTARY RELOCATION CONDITION SURVEY AND FEASIBILITY REPORT

8/26/2020

## **BUILDING CONDITION SURVEY**

### **EXECUTIVE SUMMARY**

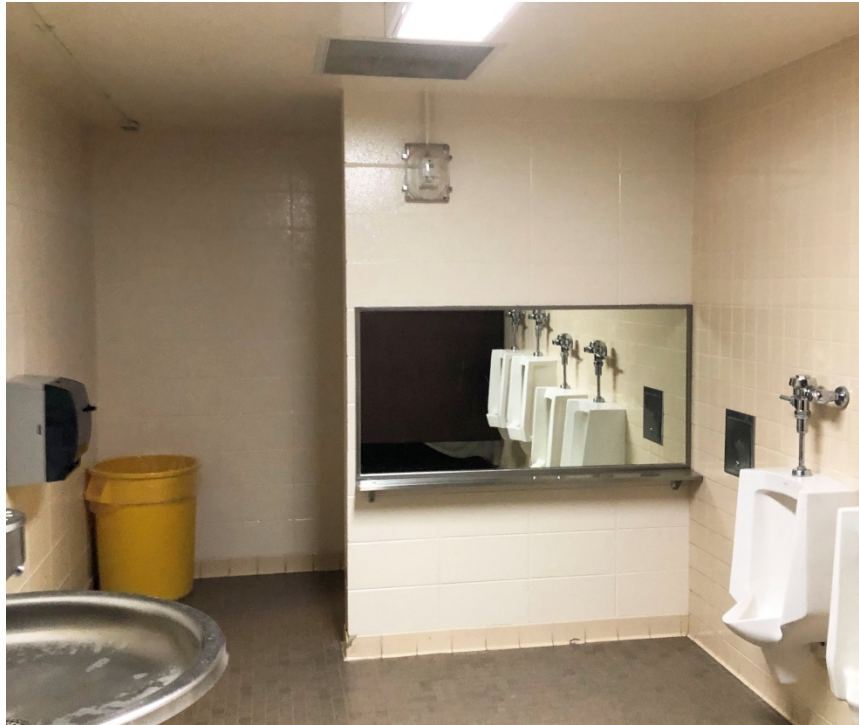
*The restrooms are showing signs of wear and do not have ADA compliant toilet stalls.*

In general, the restroom finishes were in fair condition. The ceramic tile floor finish looked clean and well cared for. The team did note that the ceramic floor tile looks worn in some locations, and the grout appears to have collected some dirt over the years. The ceramic tile wall base was chipped in at least two locations in Boys Restroom 52.

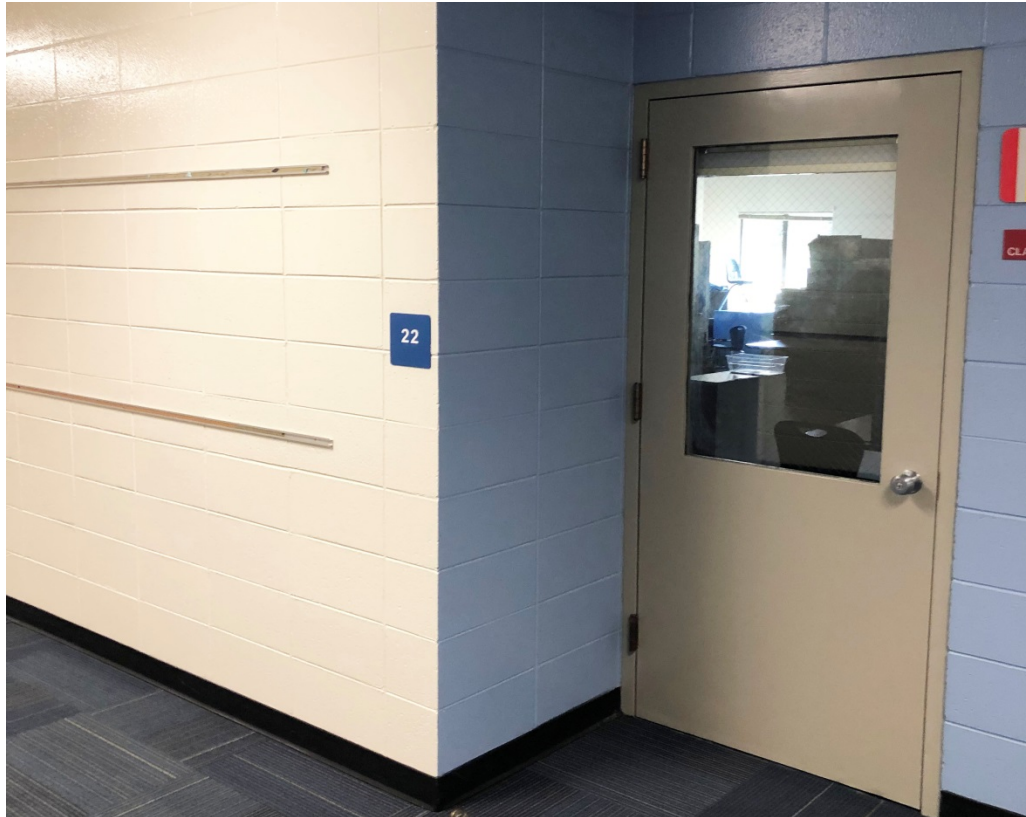
ADA also requires that doors have lever style handles which are operable by a person in a wheel chair. A lever style handle is typically easier to use for a disabled person than a residential knob style handle that requires a pinching motion and twisting of the wrist. Virtually all the doors along the main corridor have 'knob' style handles. This door hardware does not comply with accessibility requirements and should be replaced.

*The doors along the main hallway do not have ADA compliant lever style handles.*

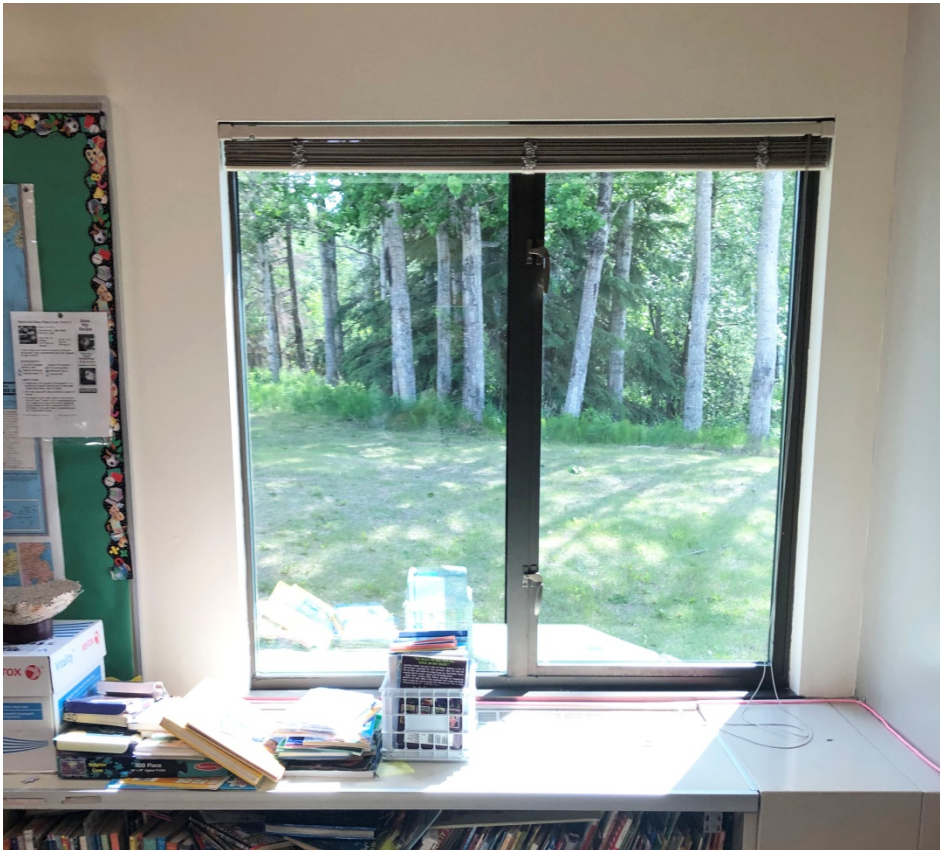
The existing windows on the north side of the building were replaced earlier this year. The south side windows will be replaced on an “as needed” basis during the District’s regular maintenance cycle.

*The existing windows have been partially replaced with newer, more energy efficient insulated units. The remainder will be replaced over the next few years.*

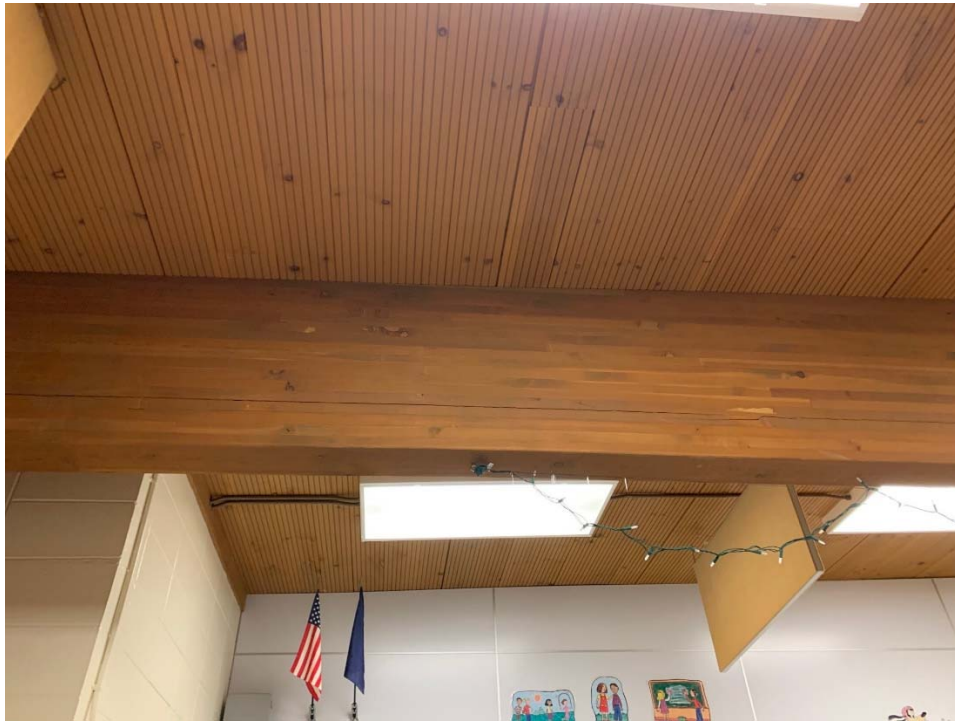
- 2. Non-load bearing partition walls CMU walls can be removed for programmatic needs.
- F. ROOF STRUCTURE
  - 1. The roof structure is comprised of 3" Tongue and Groove wood decking over GLBs. The fit-up of the tongue and groove roof deck is questionable and may be askew due to several earthquakes that could have caused movement within the roof. Overall, the roof structure is in good condition. No excessive deflection, water damage, nor rot was noted during the site inspection.

*Poor fit-up in tongue and groove deck*

- a. We recommend viewing the tongue and groove decking from above when the reroofing effort is completed to assure there are no issues with fit-up that will prevent the structure from performing as intended.

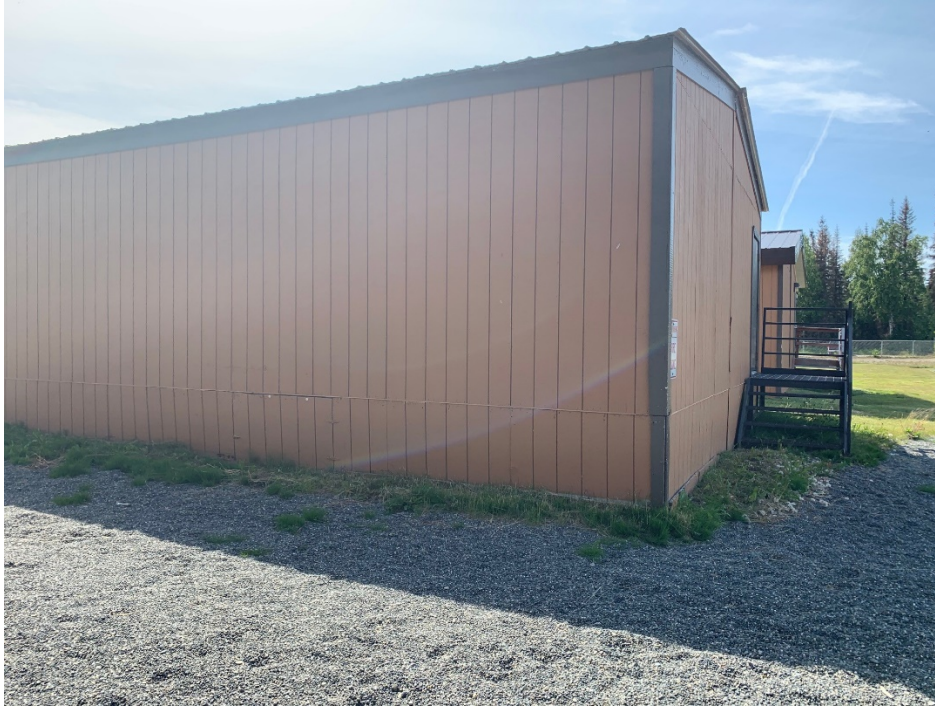
- G. PORTABLES
  - 1. The portable structures appear to be in poor condition overall. The roof, flooring, and skirt walls all have experience expected creep deflection over time and the buildings appear to be nearing the end of their useful life.

*Portables in poor condition*

2. The portables are in poor condition. We recommend making plans to relocate the space and either discontinuing the use of the structures or having the structural members inspected for damage.

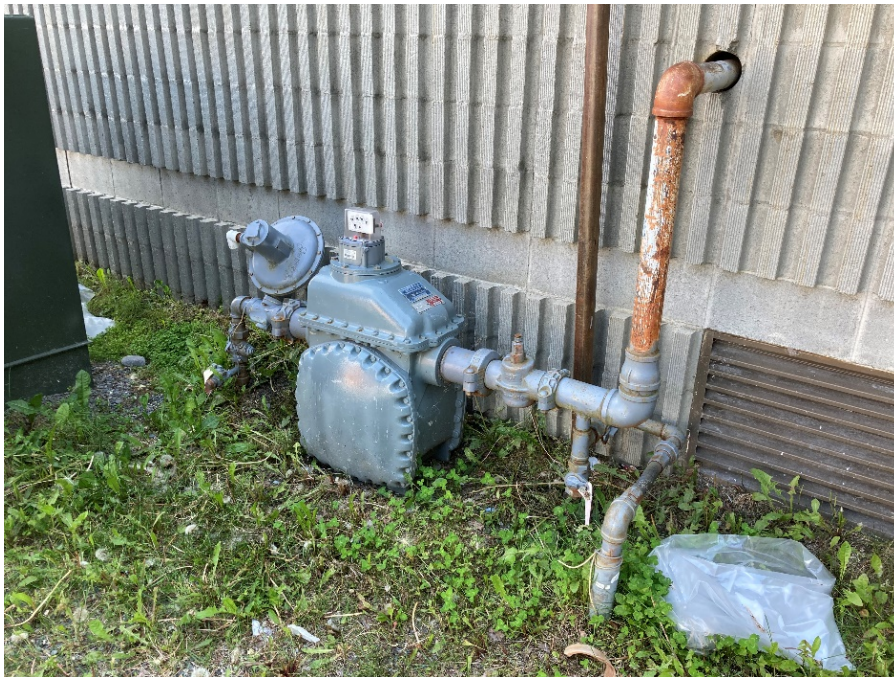
1. An Enstar natural gas meter is located on the exterior north side of the building. The gas meter and regulator is in fair condition.

*Gas meter at rear exterior of school*

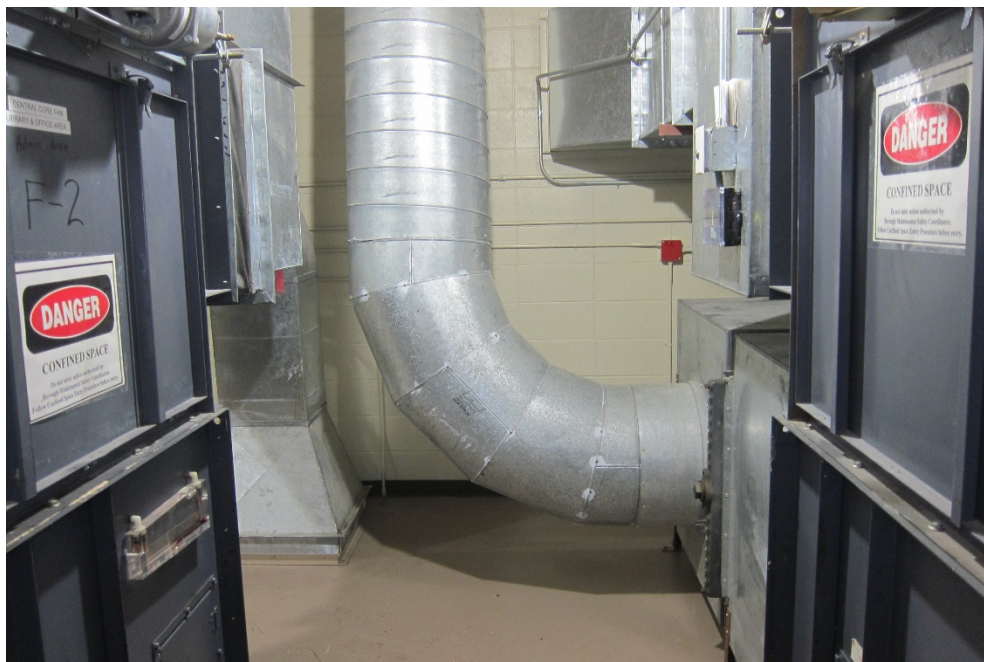
*Multiple fan units are original construction*

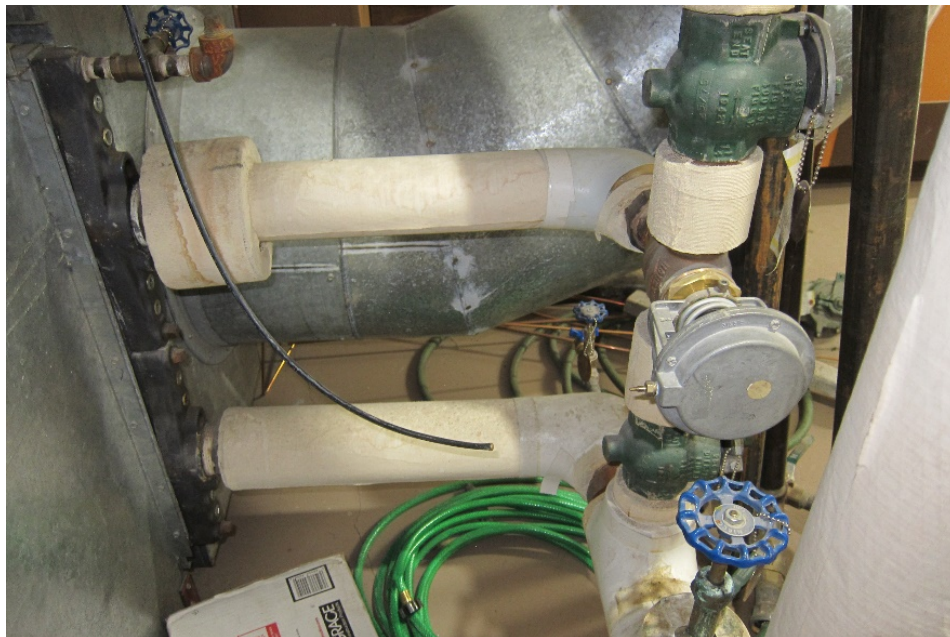
*Air unit heating coil piping with pneumatic line disconnected*

6. Fan damper actuators are all pneumatic and are original construction. One damper actuator has pneumatic line tubing disconnected.
7. No VFD's (Variable Frequency Drives) are used for any of the fans.
8. Ducts and diffusers are generally in good condition. Some diffuser faces have light surface wear that includes scratches and chipped paint. Wall and ceiling grilles are dusty or dirty and require cleaning.

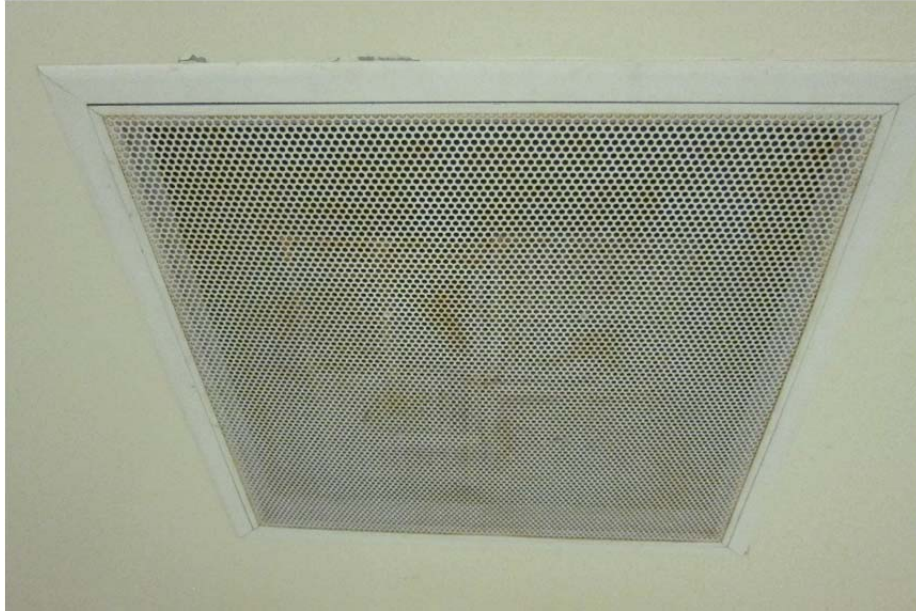
*Ventilation grilles and diffusers require cleaning*

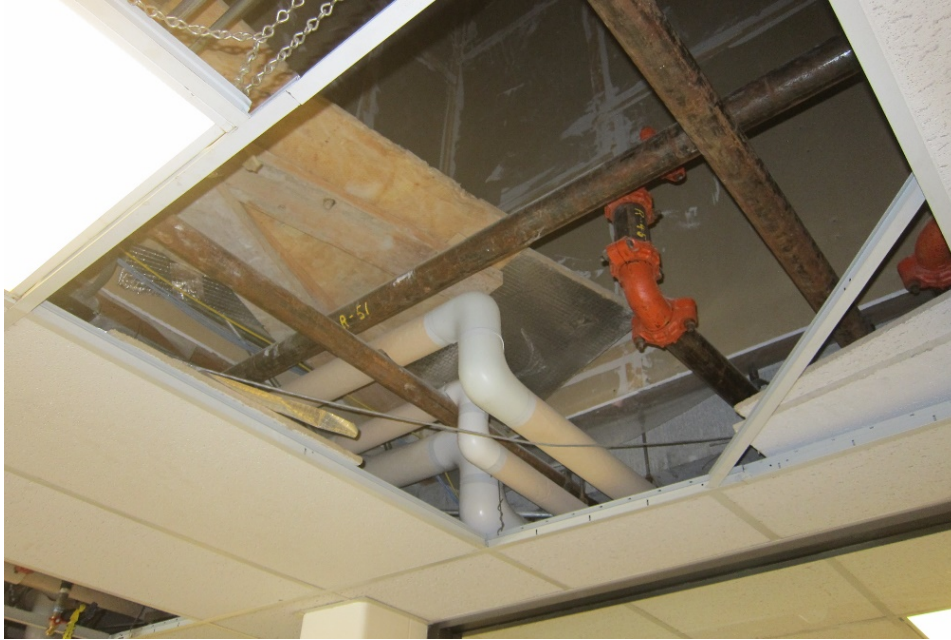
6. Piping in the mechanical room is in good condition. Some of this piping is being replaced in the current boiler upgrade project. General building heat piping shows signs of external corrosion. Piping insulation is in generally fair or poor shape from what was exposed. There are no signs of system leaks.

*Piping conditions above ceiling with external corrosion and missing insulation*

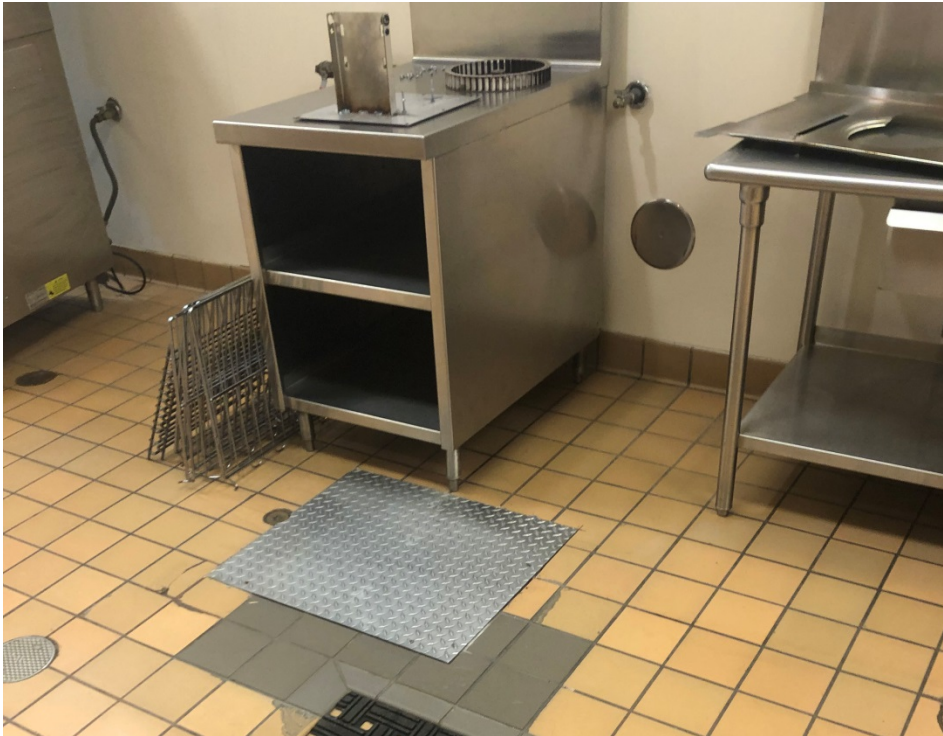
*The tile base in the kitchen is chipped or cracked in a few locations.*

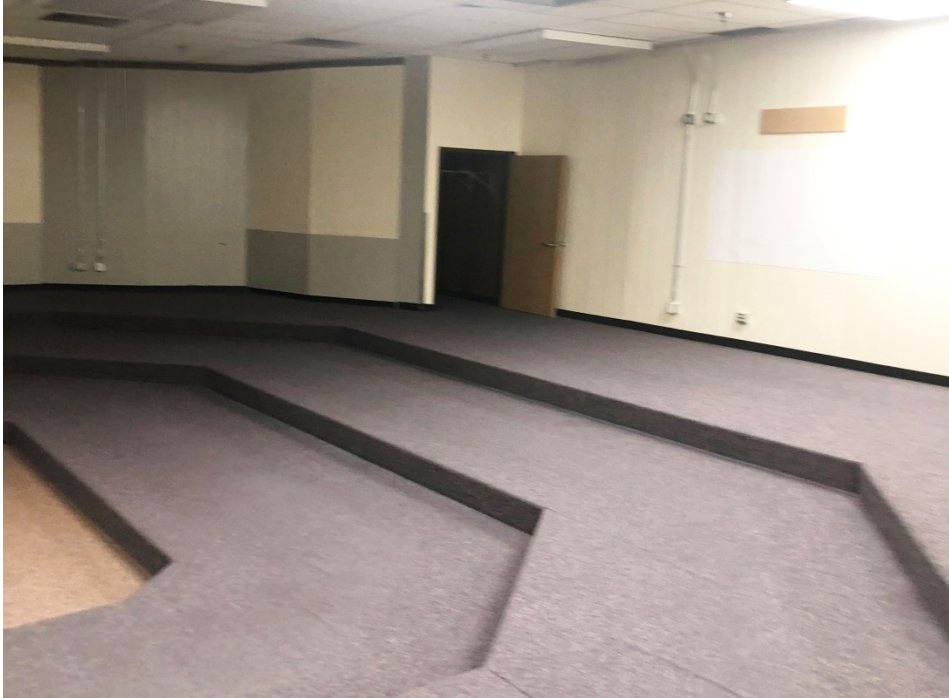
ramp that had been installed over part of the tiered seating. The tiers themselves are fairly deep in terms of their horizontal depth, but shallow in height. (The as-built drawings show them as being approximately 8 inches high.)

*The tiered seating in the main music room/band practice space is not accessible.*

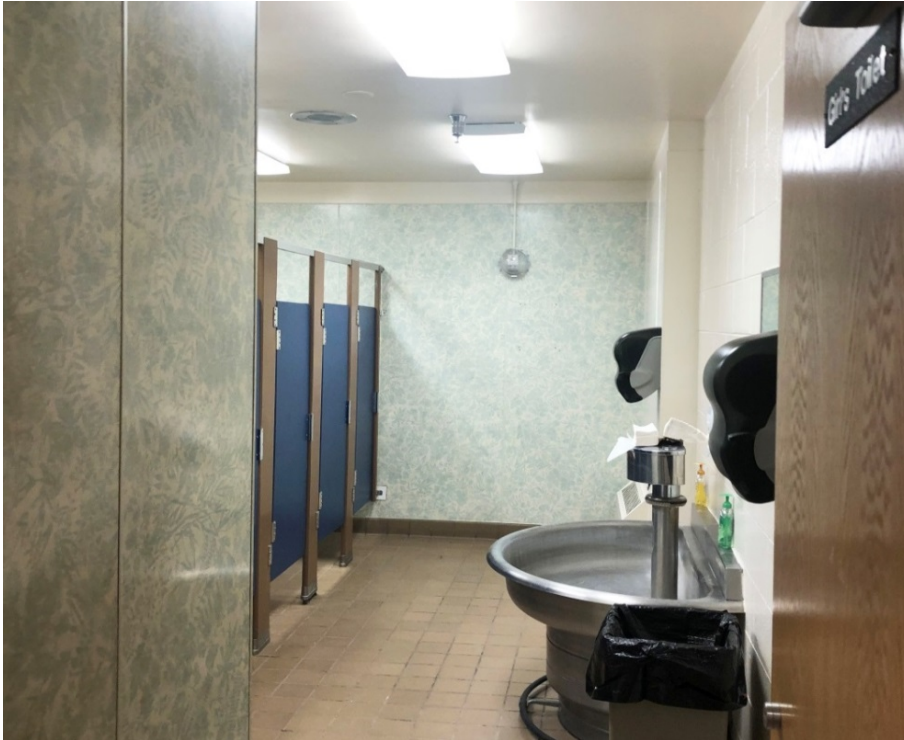
*Restrooms in the south half of the school typically have some ADA accessibility issues.*

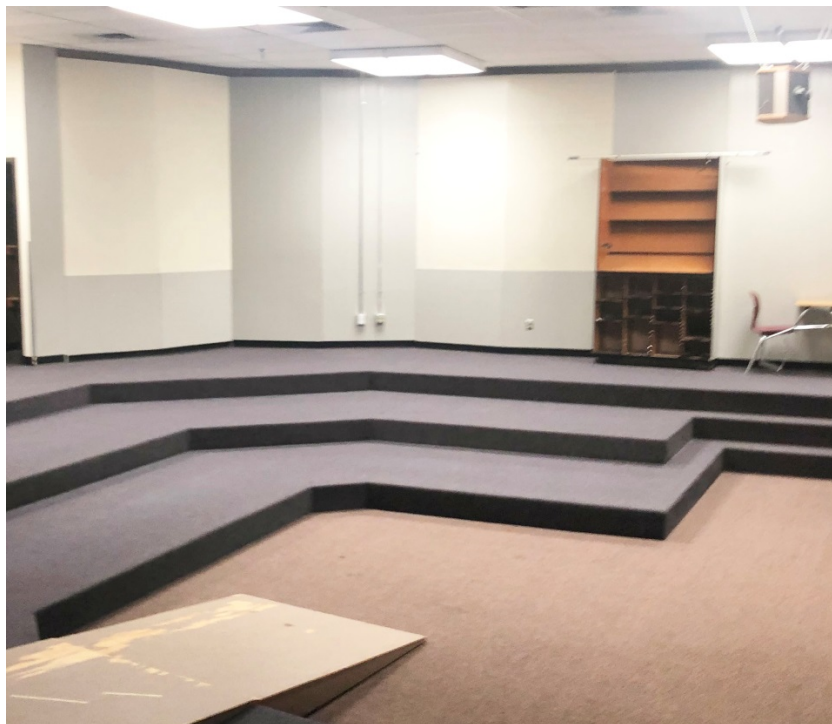
The main music room space has a tiered floor that descends in three steps to the lowest level of the music room. The room is configured this way to allow the school band to practice together as a group. Each level is roughly five feet deep, with an eight inch riser between each level.

*The tiered performance area in the music room does not have an accessible means of access.*

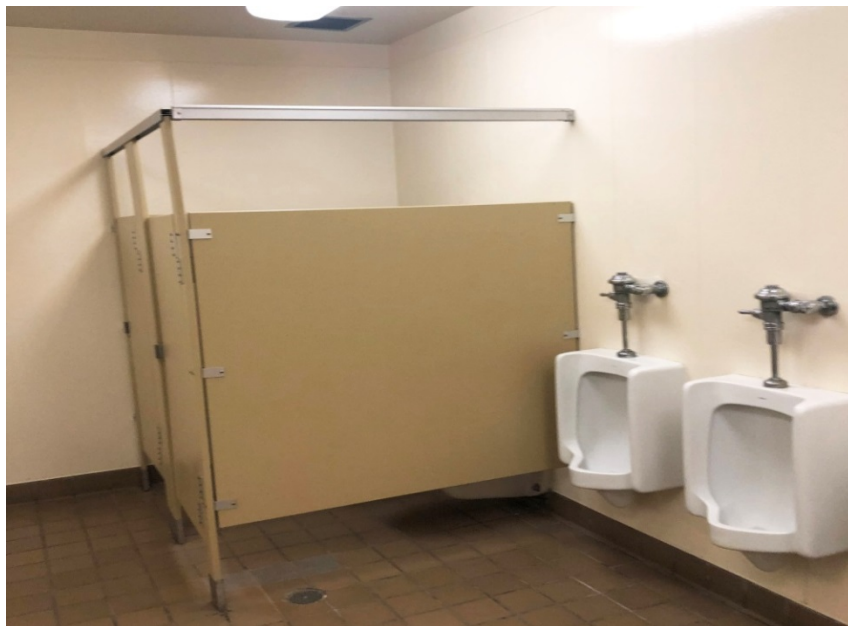
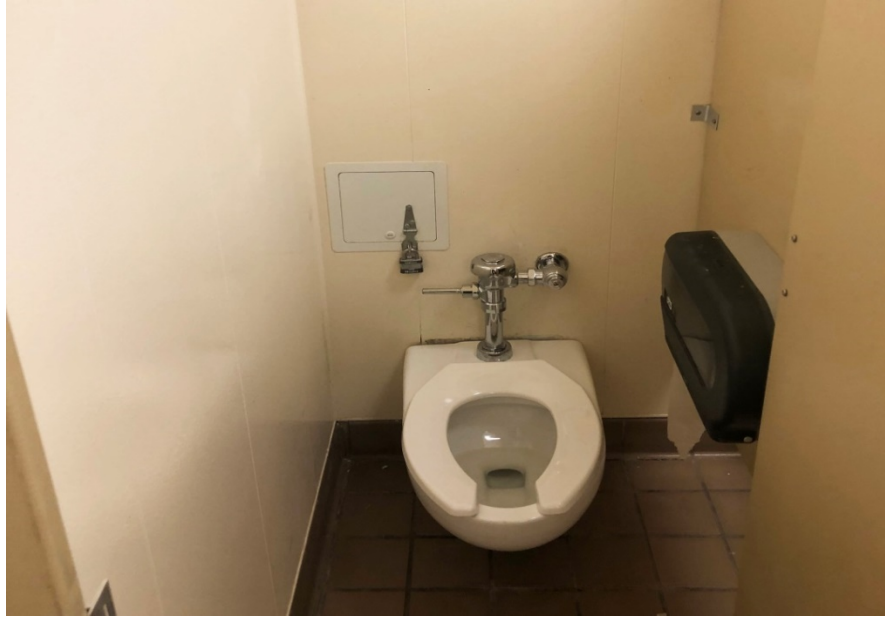
At least one toilet stall must be equipped with grab bars, and have enough room in the stall to accommodate a five foot by five foot clear area around the toilet fixture. At least one lavatory must also be accessible (that is, mounted at 34 inches above finished floor with the requisite clear floor area below.) Section 1109.5 requires a minimum of two drinking fountains to be provided. One must be mounted with the height range required by ADA.

*Neither the boy's or girl's restrooms in the south end of the building complies with the ADA guidelines for layout or fixtures.*

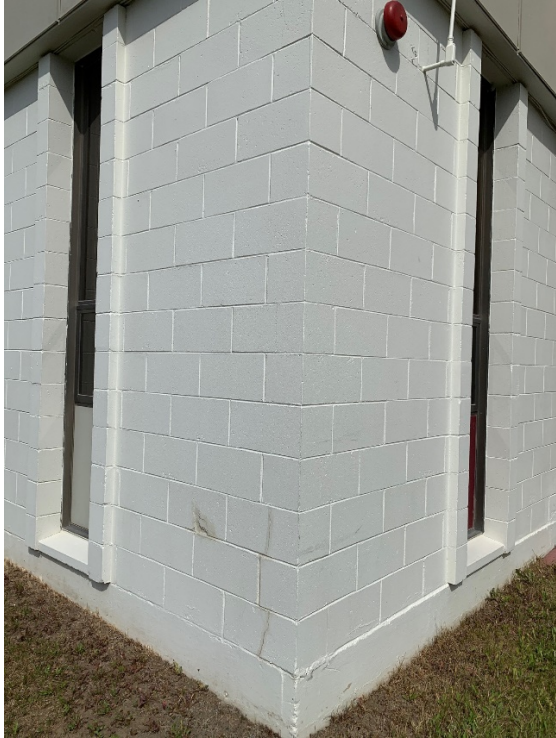
*Cracking in exterior CMU walls*

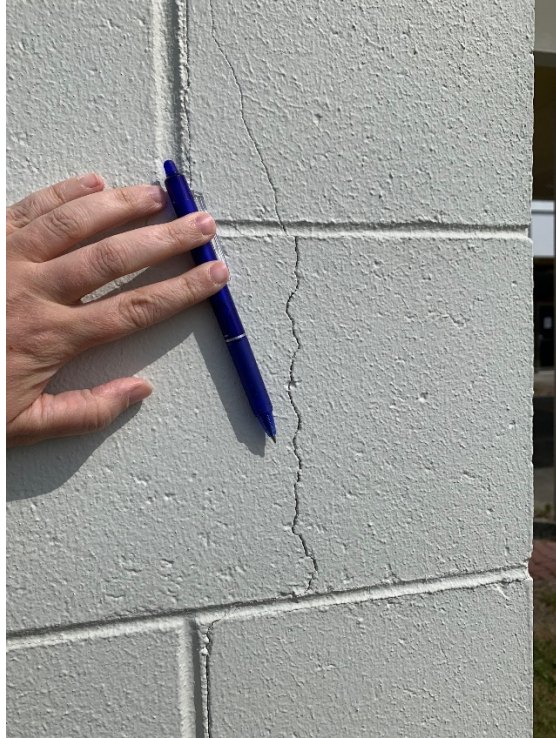
*Enlarged view of cracking in CMU walls*

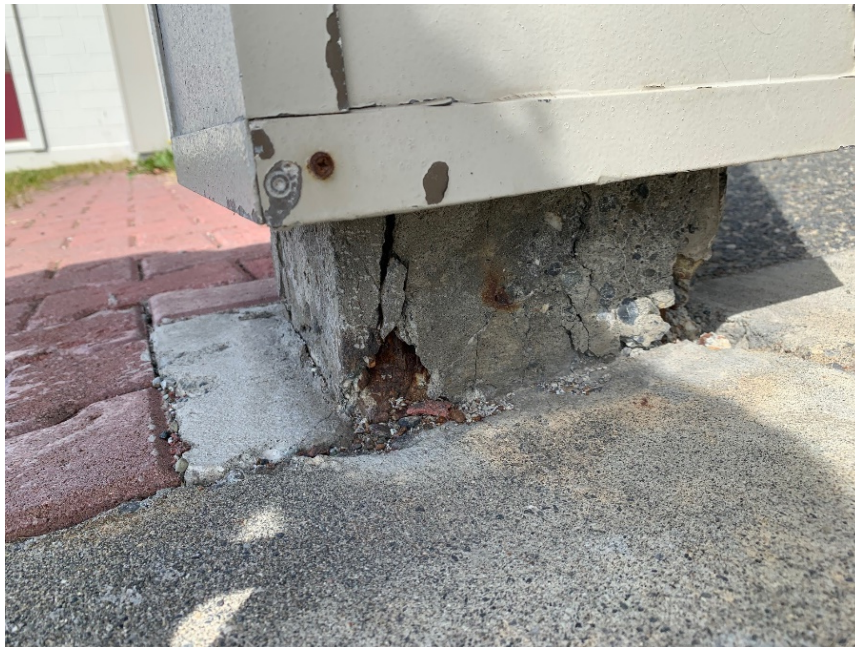
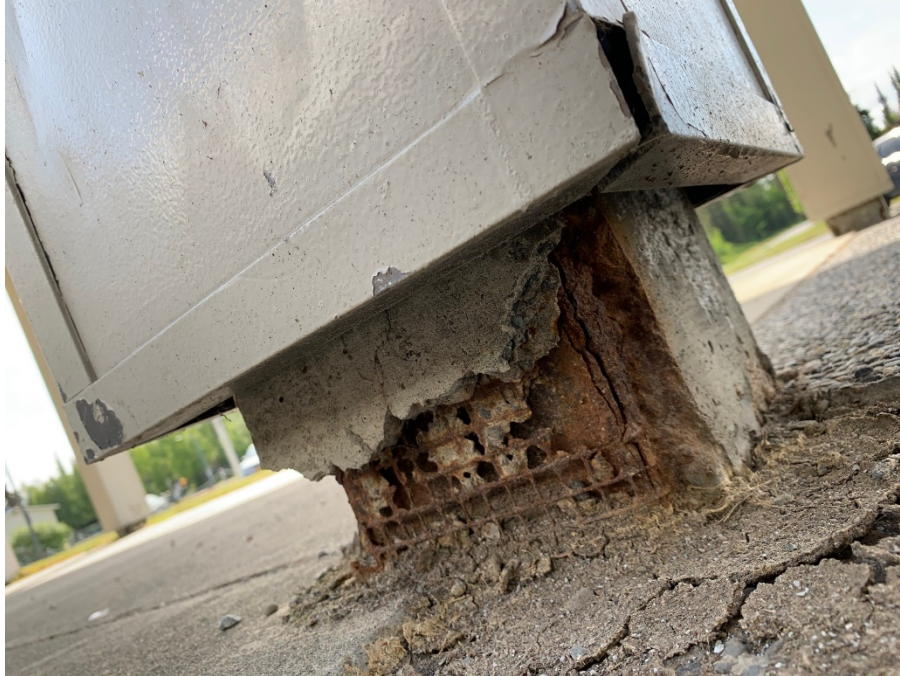
*Typical damaged column base at school entrance*

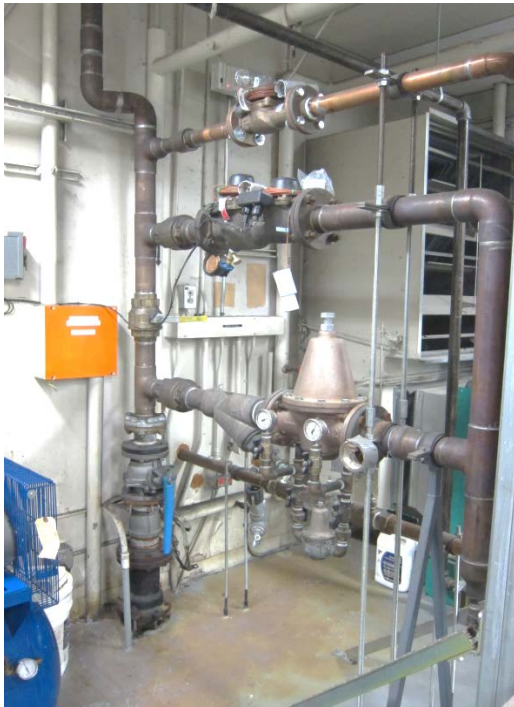
*Water entry in boiler room*

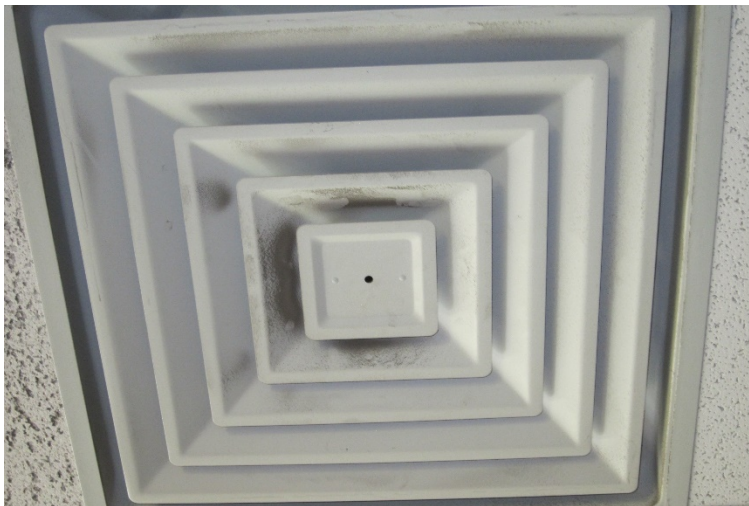
*Diffusers require general cleaning*

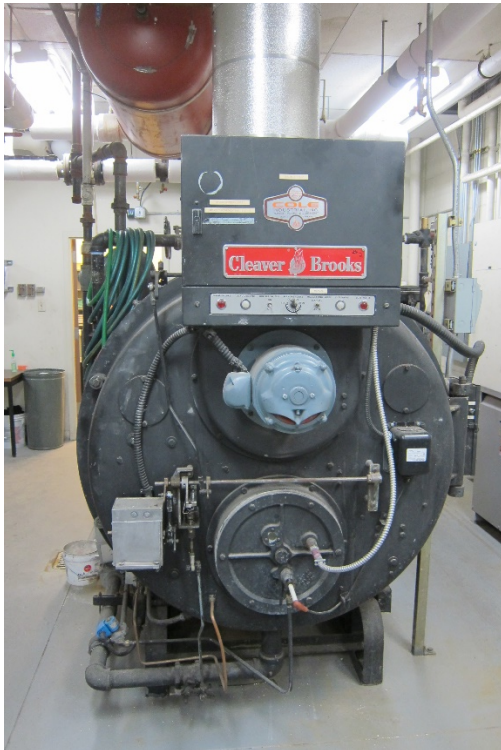
*Older fire tube boiler at end of life*

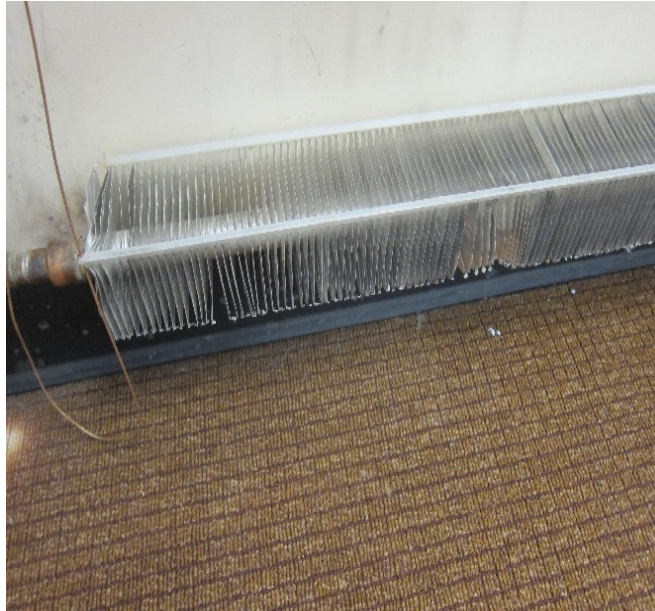
*Classroom finned tube exposed with bent fins*

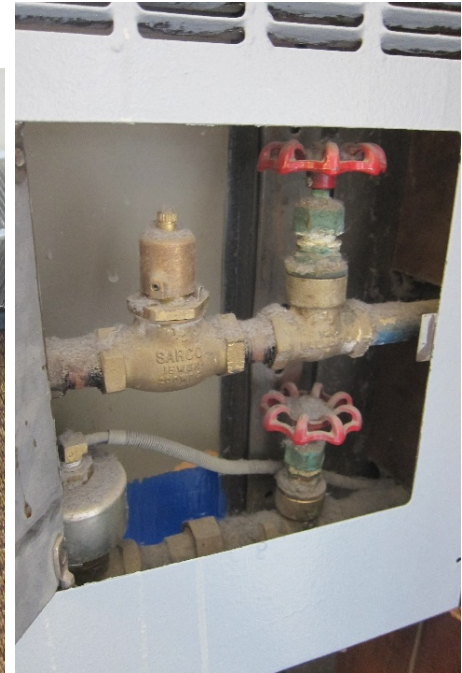
*Terminal unit valves and piping in aging condition with pneumatic control valves*

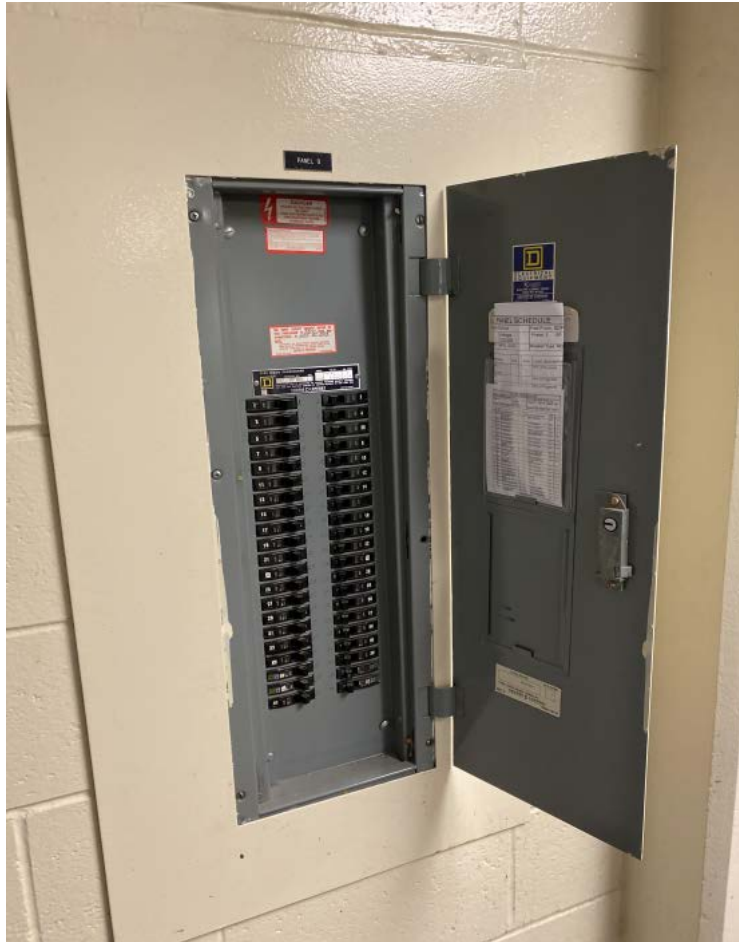
*Example panel in hallway (no spares or spaces)*
