# KPB SOLDOTNA ELEMENTARY RELOCATION CONDITION SURVEY AND FEASIBILITY REPORT

8/26/2020

## **BUILDING CONDITION SURVEY**

### **EXECUTIVE SUMMARY**

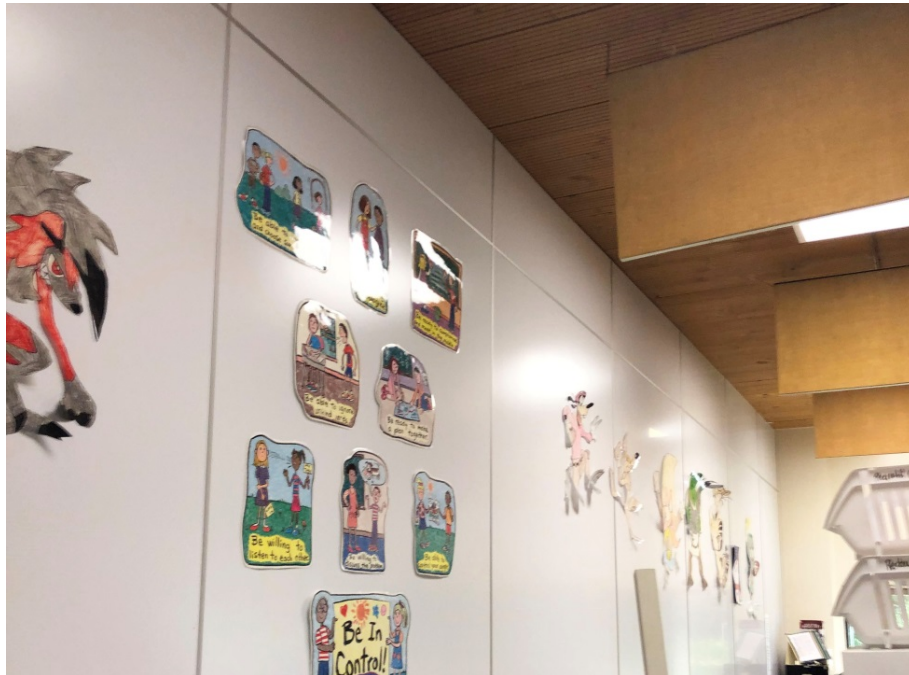
Based on reports from the facilities staff, the option of moving the operable partitions is very seldom used. Although the partitions bring the advantage of greater flexibility in layout, they also have some disadvantages. One of these is easier transmission of sound from room to room. One of the facilities staff noted that the movable partition separating the intensive needs classroom from other classrooms had to be replaced with a permanent wall to cut down on disruptive sounds from some of the special needs students.

*Pairs of classrooms are separated by operable partitions that can be manually opened.*

Without the sound deadening mass of a typical, sound batt insulated partition wall, sound typically finds flanking paths around the top and bottom of an operable partition. The sound transmission can be reduced with careful sealing of the top, bottom and edges of the partition, but this is still not as effective as a well-built permanent wall.

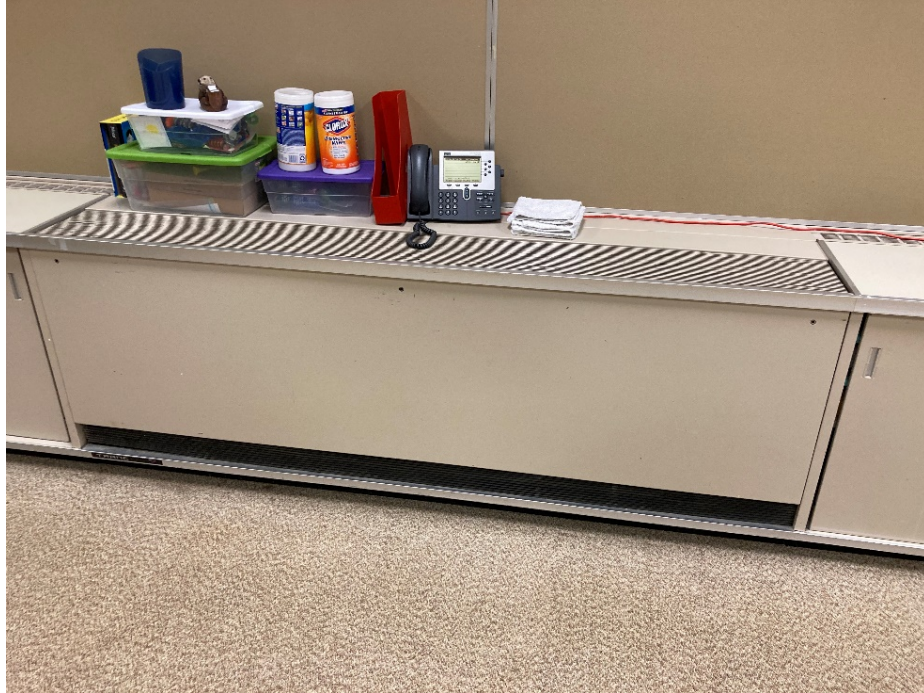
*Fan coil units built into classroom cabinetry*

3. No VAV boxes are present. Instead, the building uses duct reheat coils for each zone of the building.
4. The air handling units and fans are the original equipment installed. These units are in working order, but are at the end of their useful life.
5. Heating coil piping and valves for air units show external signs of age and corrosion.

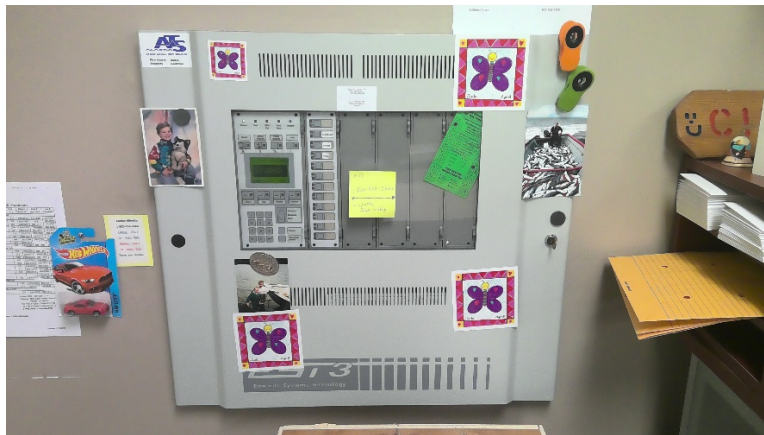
*Redoubt main fire alarm panel in reception area*

As noted in the architectural and mechanical sections of the report, there is no fire sprinkler system in the building. If a sprinkler system is installed, code compliant tamper switches and a flow alarm will need to be added to the water service.

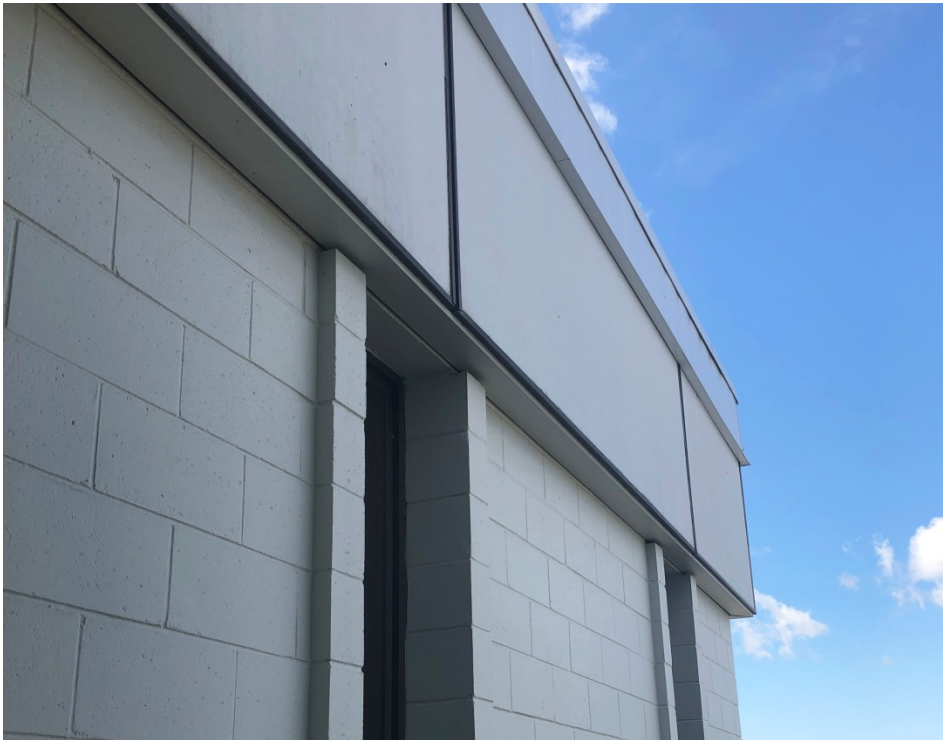
The exposed CMU of the exterior envelope appears to be in relatively good condition. The surface paint is not chipped or spalling. No obvious signs of earthquake damage were visible in the form of large cracks or missing blocks.

*The exterior CMU is in good condition and shows no signs of damage.*

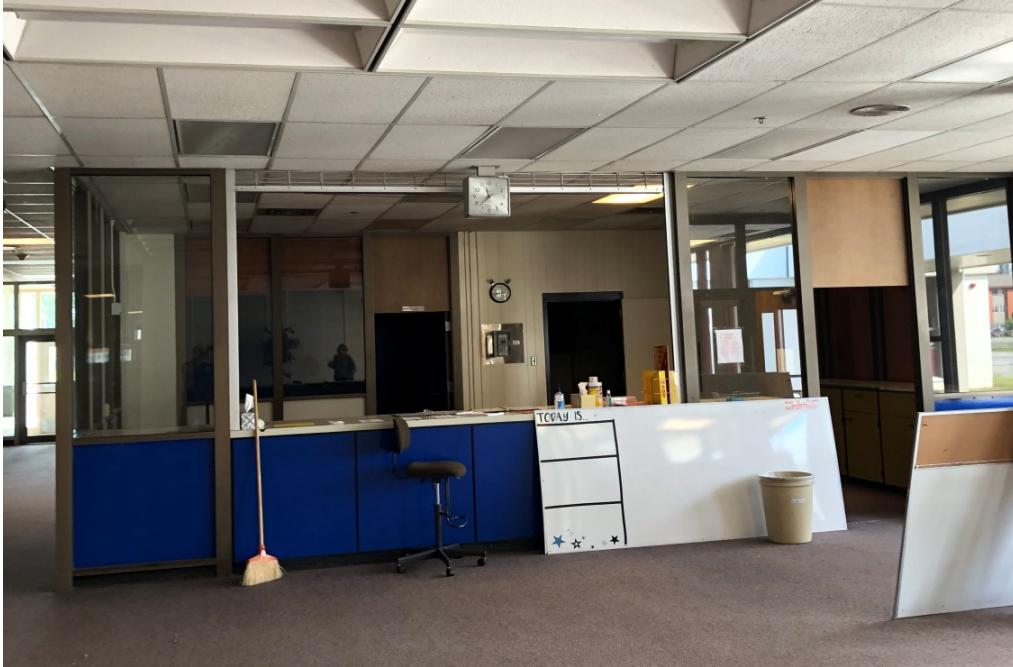
The team observed that the painted CMU walls were generally in good to fair condition. Upper and lower cabinets in many rooms appear to date to the late seventies or early eighties, and are showing signs of wear. The window blinds appear to date to the same era, and many of them are broken, or in poor condition. Carpet by the main reception desk was very worn down.

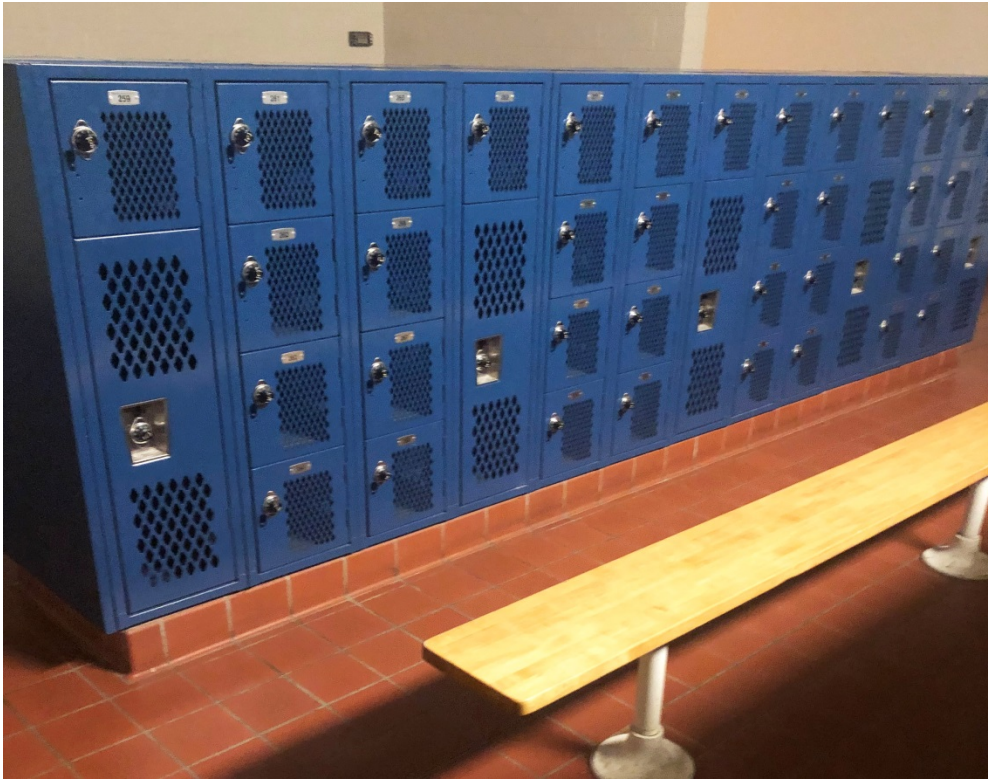
*The locker rooms and shower areas are in good condition, but unlikely to be used by elementary students.*

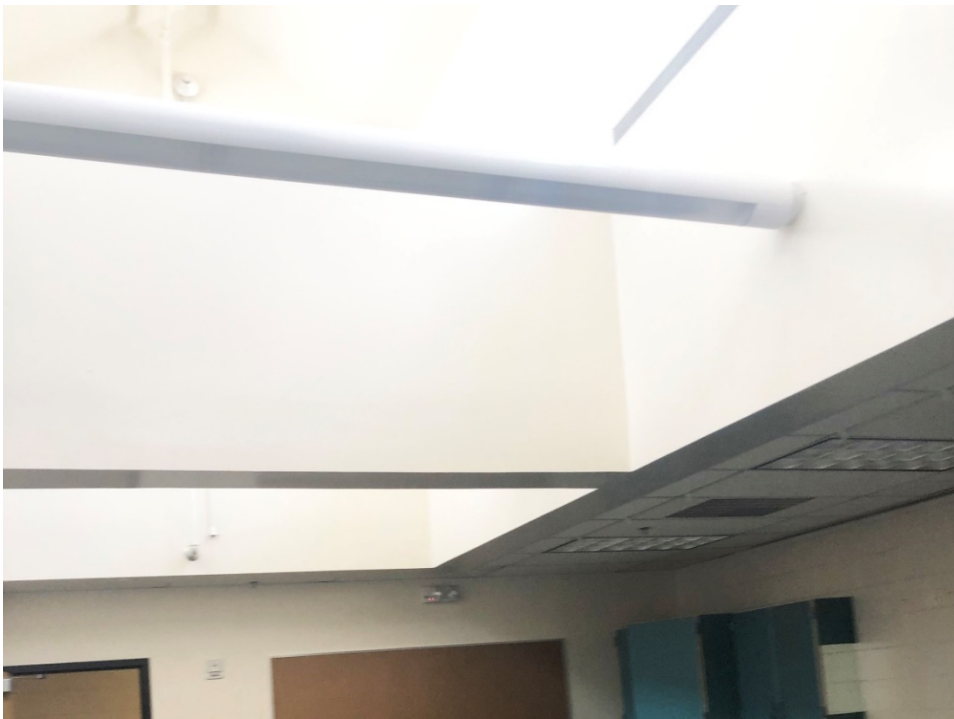
*New classrooms added in the 2003 renovation are smaller, and have only indirect access to natural light.*

The carpet in some of the classrooms is worn. In one case, a hole or gap in the carpet had been patched with a piece from a different carpet of another color.

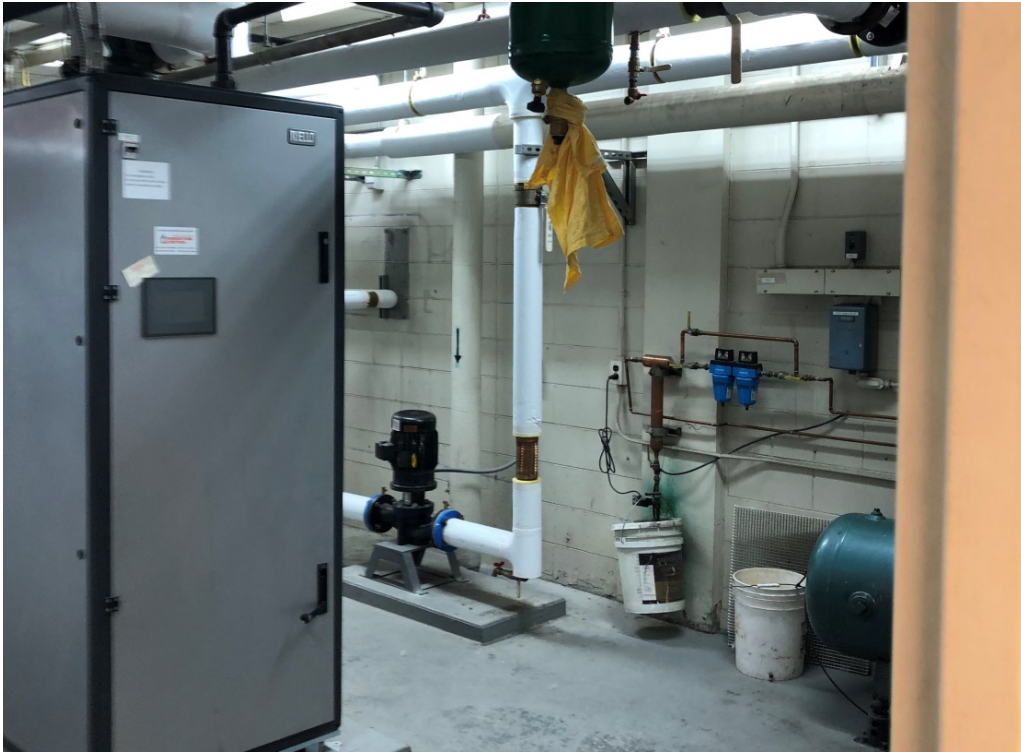
From the interior of the school, the boiler room must be accessed by going through the main electrical room. An exterior set of double doors allows direct access from outside for deliveries. Both the boiler room and the electrical room appear to have been kept relatively clean. The team did not see inappropriate storage of furniture or flammable items that sometimes occurs in mechanical spaces.

*The main boiler room is clean and well maintained.*

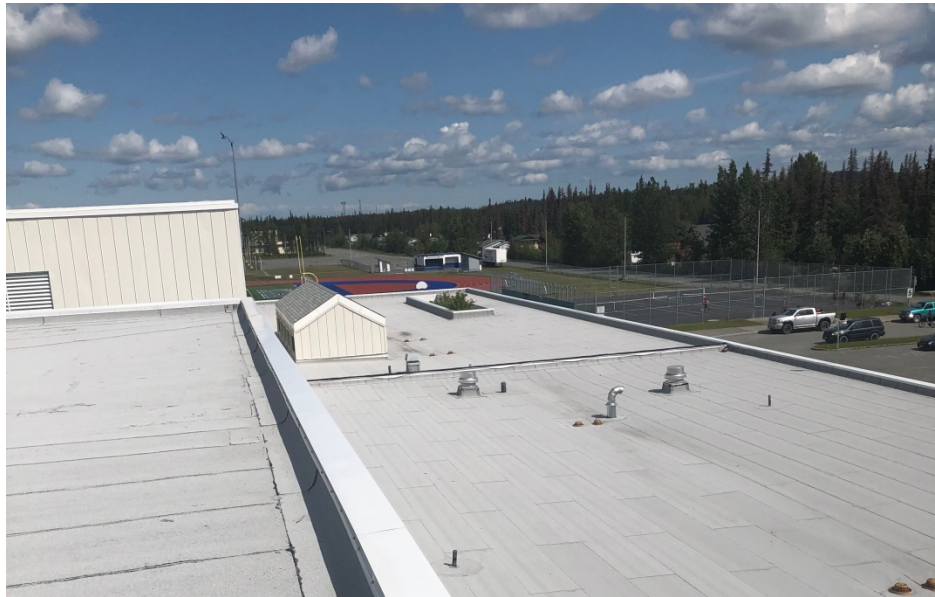
As noted earlier, the roof assembly for the entire school building was replaced in 2015. Based on the available information, the new roof assembly meets or exceeds the minimum guideline of R-35 in the IECC.

*The roof of the school was replaced five years before the date of this report.*

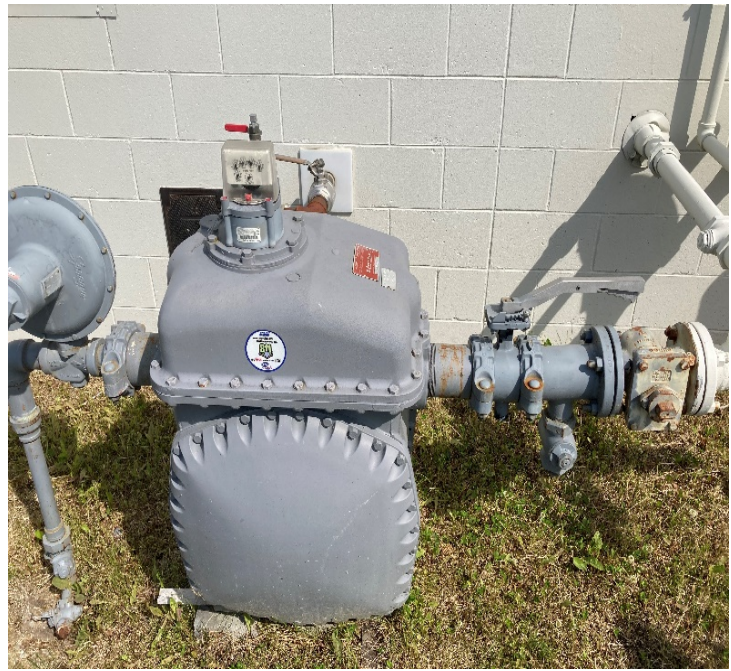
*Gas meter on west side of school*

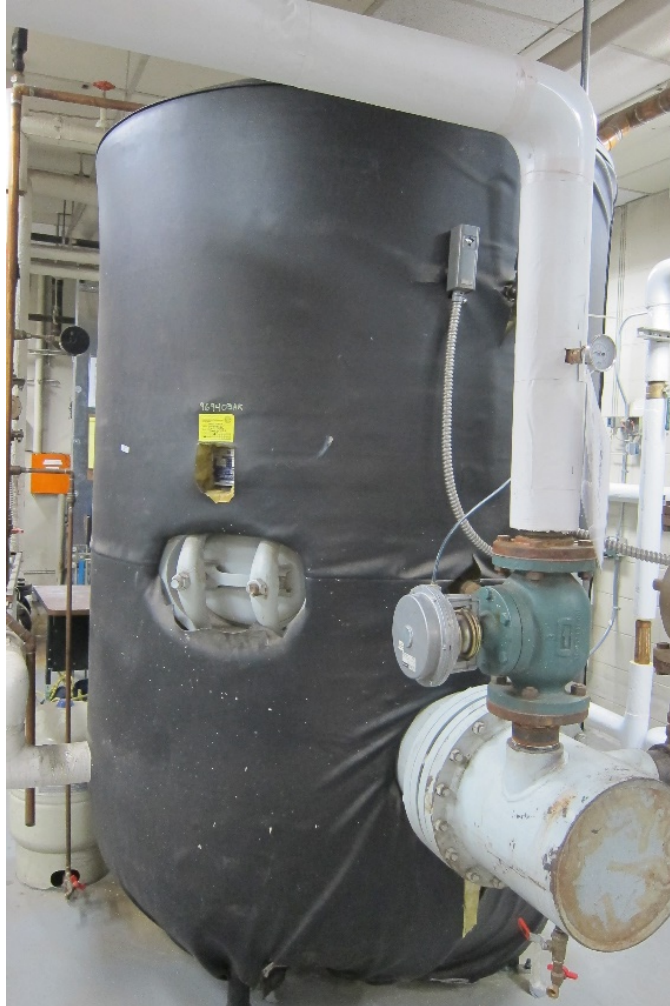
5. Roof drains were in weathered yet fair condition. There were no signs of drain pipe blockage.
6. The hot water generator in the mechanical space is a 740 gallon shell and tube indirect type that was built in 1994. It is in fair condition. It is nearing the end of its useful life of 30 years.

*Water heater in boiler room*

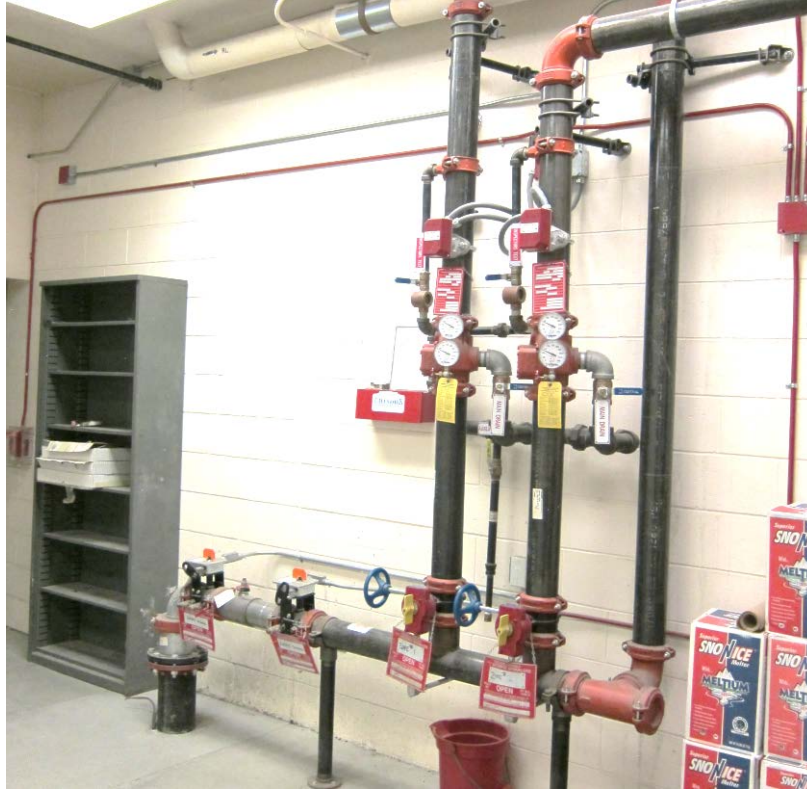
7. Many of the classrooms do not have sinks, which is a common need for elementary age students.
- Q. FIRE PROTECTION
1. Fire service entry enters the building in a designated fire protection room in the building. The building is divided into two primary zones for fire protection service. Each zone main valve is tagged with hydraulic testing and flow data from 2003 and 2004 with Light Occupancy classification.

*Fire riser with two zones in fire sprinkler room*

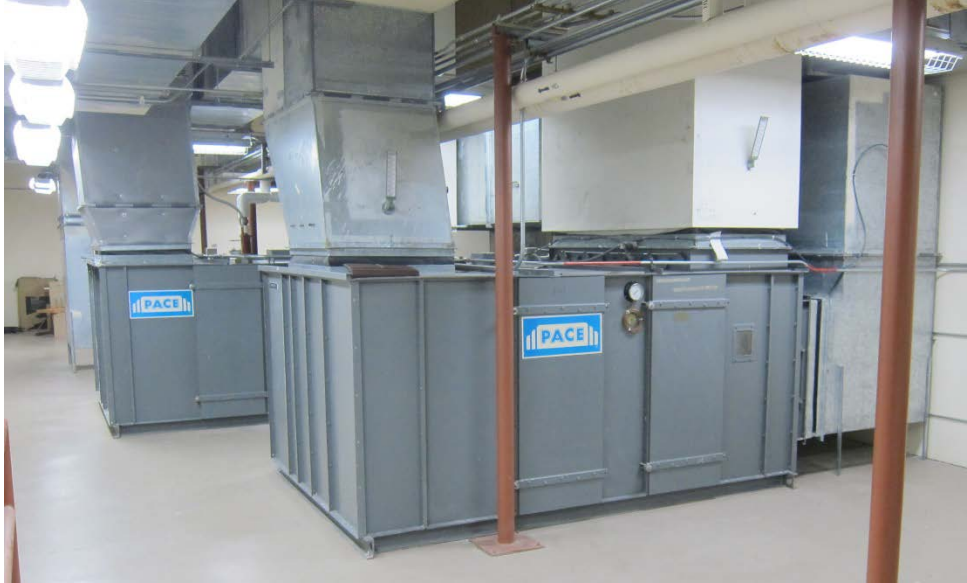
1. Two fan rooms comprise of multiple fan units with heating coils that distribute constant volume ventilation to all classroom and building spaces. One fan room primarily serves one of the gymnasiums.
2. No VAV boxes are present. Instead, the building uses duct reheat coils for each zone of the building.
3. No heat recovery systems for any of the ventilation equipment are present. The air handling units and fans are the original equipment installed. These units are in working order, but are at the end of their useful life.

*Fan units are all original installed equipment*

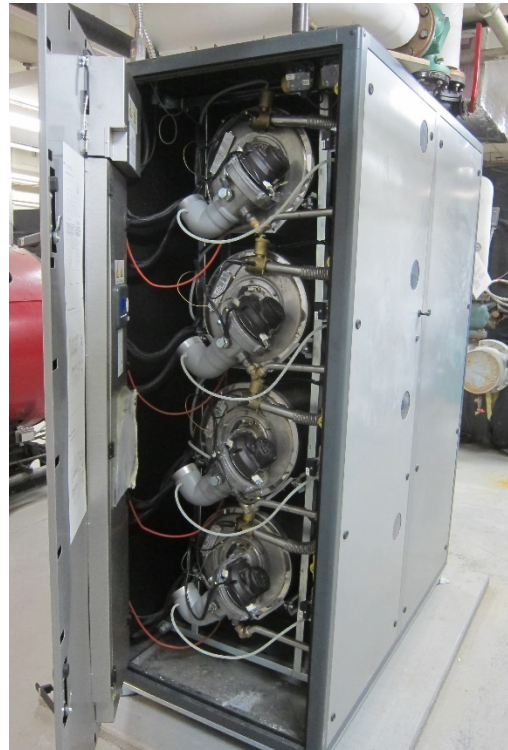
*New boiler installed in 2017*

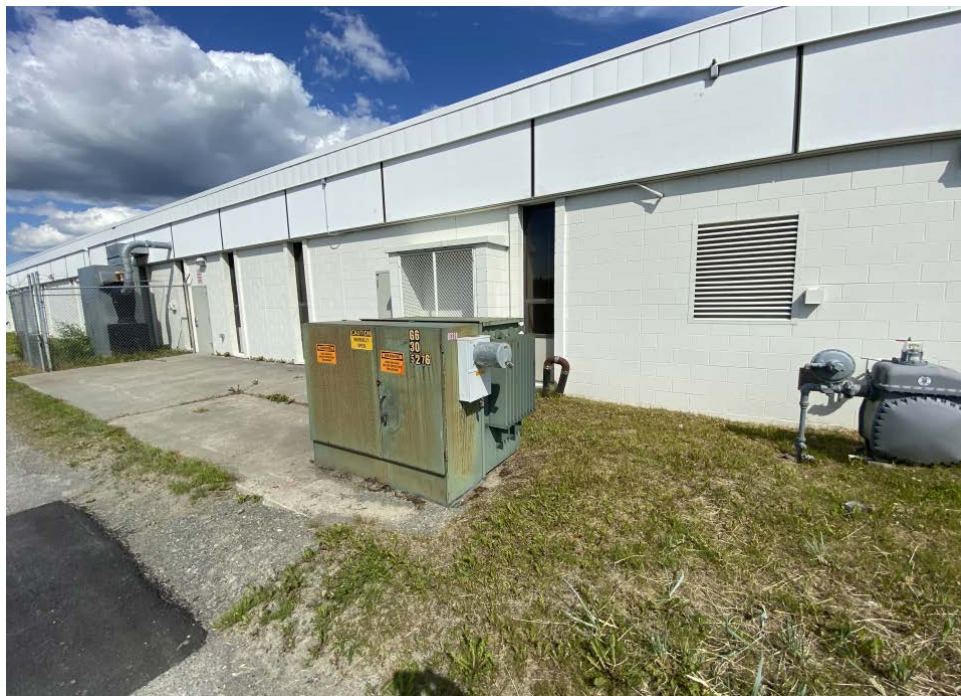
An underground power service from the Utility is installed on the plan west side of the facility. There is a pad mounted transformer and the meter is mounted on the side of the transformer enclosure. Service equipment enclosures are in fair condition. There is currently no way to shut off power from the exterior of the facility (both normal and generator backup), violating NEC Article 230.

*Main power service on west side of school*

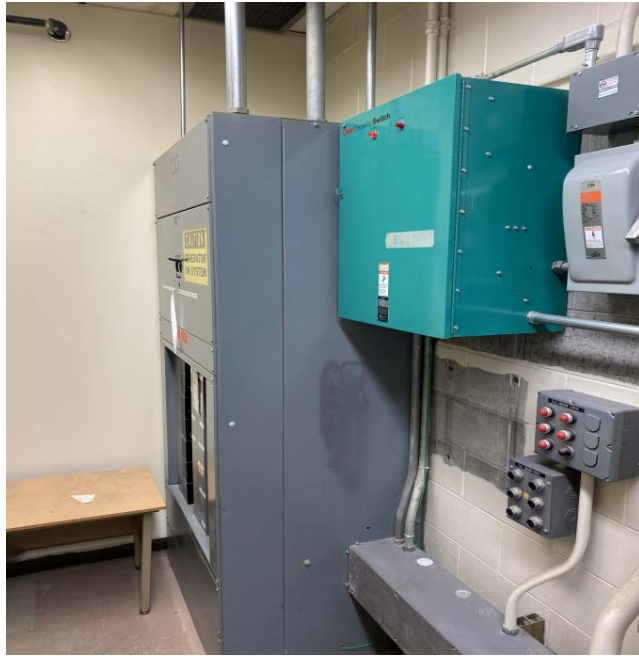
The MDP is in the main electrical area, which is inside of a gated room and is rated for 800 amps, 480Y/277V (Square D Power-Style Switchboard). The MDP is older but in fair condition.

*Main Distribution Panel and ATS*

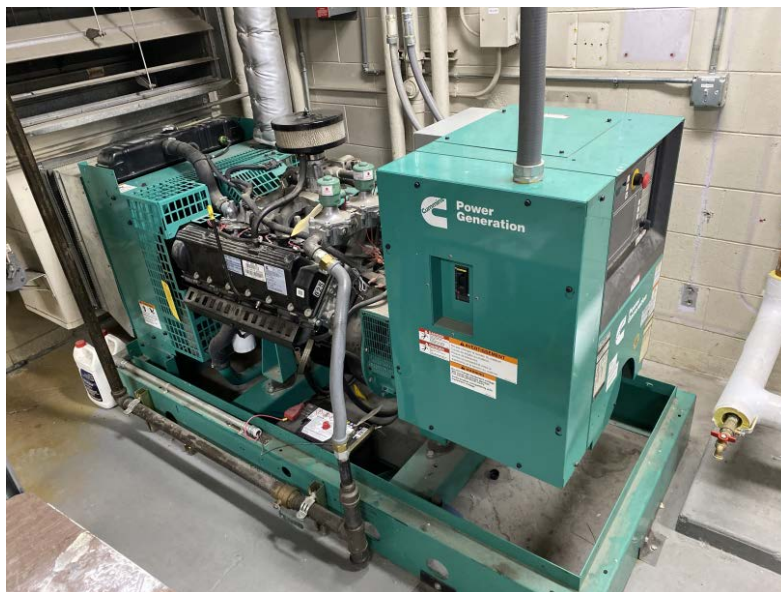
There is a backup generator located in the mechanical room. This powers an automatic transfer switch and certain emergency and optional standby loads which are shared on one distribution branch. The generator is a Cummins 60 kW standby (model GGHE-4387209). The ATS is an Onan 60amp, 120/240V, 1ph, 4 wire ATS (model LTCU 60-L/86H). The generator and ATS are in good condition and these appear to have been recently installed.

*Backup power generator*

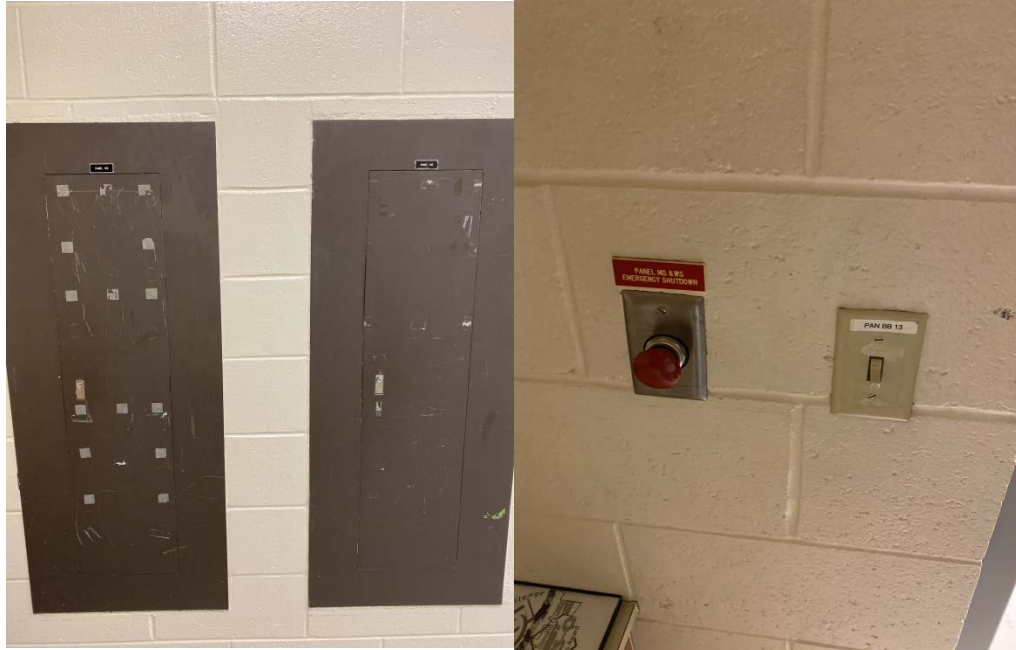
The shops and art spaces have dedicated panels and multiple emergency shut off mushroom style pushbuttons. When a button is pushed, power at the source panel is disconnected and shut off for safety. The shop and art panels are in fair condition. There is a dust collector outside of the wood shop that is in poor condition, and it appears to be a unit that was installed per 1977 record drawings.

*Shop panels and emergency shut down button in shop office*

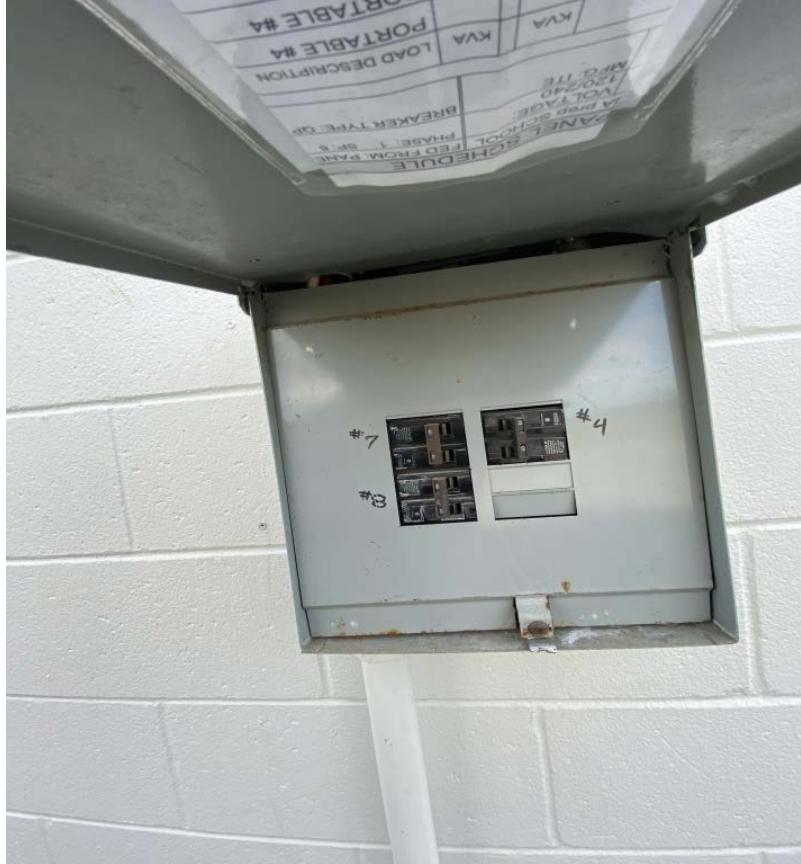
There are separate power feeders to the both the exterior sheds and an exterior panel that used to serve exterior portables. Exterior cabinets and enclosures are rusted and aging and are in fair condition. There are many exterior surface conduits and boxes installed and they range in condition from good to poor.

*Exterior panel for previous portables*

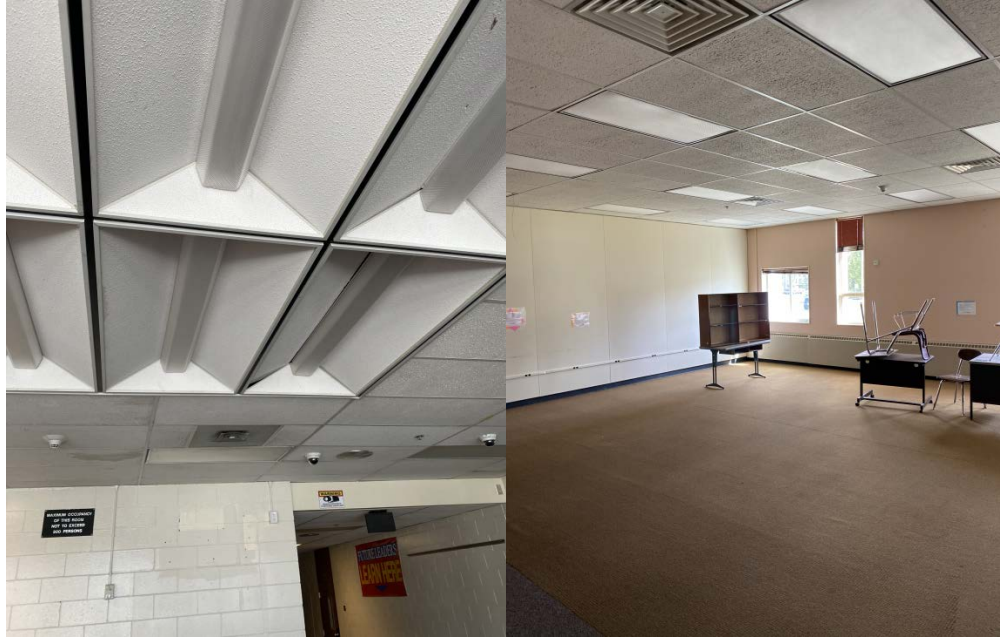
Interior luminaires utilize T8 fluorescent lamps in the majority of the spaces (with very few exceptions). Luminaires are generally in fair to poor condition. Most classroom and hallway spaces are a combination of recessed grid troffers and downlights. Most downlights had compact fluorescent lamps as the source. Utility type rooms have strip or wrap type fluorescent luminaires. The gym and MPR have high bay HID luminaires. The kitchen has a combination of sealed surface fluorescent luminaires, sealed downlights, and pendant luminaires. Some of the original fluorescent luminaires have been retrofitted with LED tube sources.

*Lighting near front entry and typical classroom lighting*

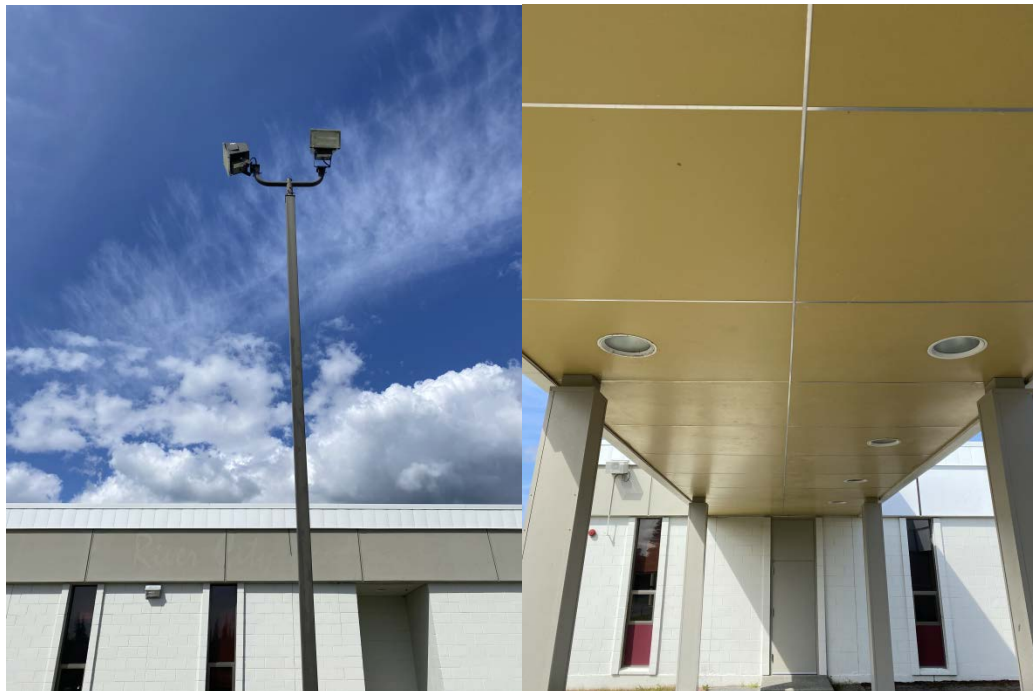
Exterior luminaires primarily utilize HID lamps (with a few exceptions). Luminaires are generally in fair to poor condition. Exterior building mounted luminaires were wall pack style. Exterior canopy luminaires are recessed lensed downlights. A few of the pole mounted luminaires on the plan east side of the property have recently been replaced with LED flood lights. Luminaires on the poles at the front of the school are older and appear to utilize HID sources.

*Pole lighting near front and front canopy lighting*

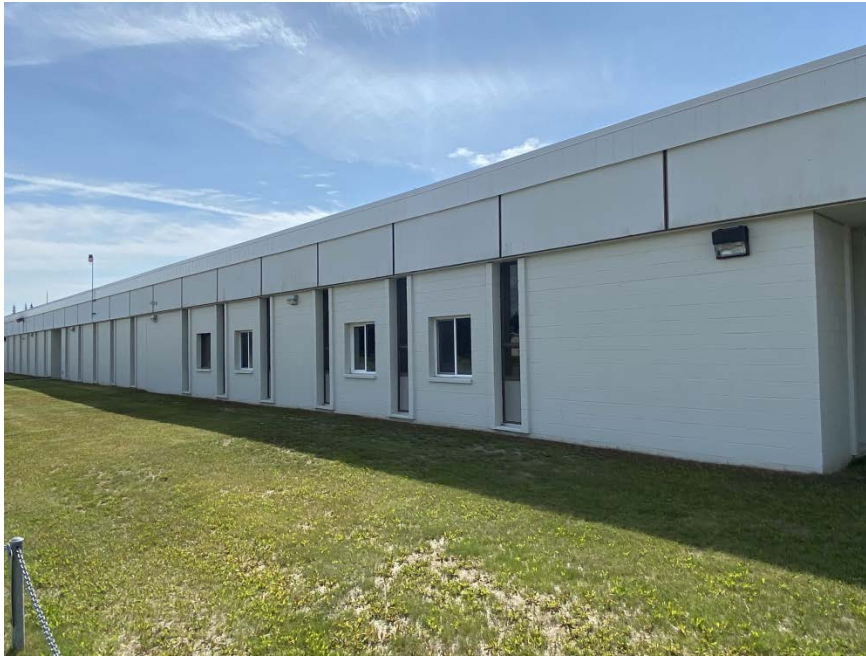
*Wall pack lighting on east side of school*
